DEFENSE CONFERENCE ON NONDESTRUCTIVE TESTING

MINUTES OF THE
15TH ANNUAL MEETING

4, 5, 6, October, 1966

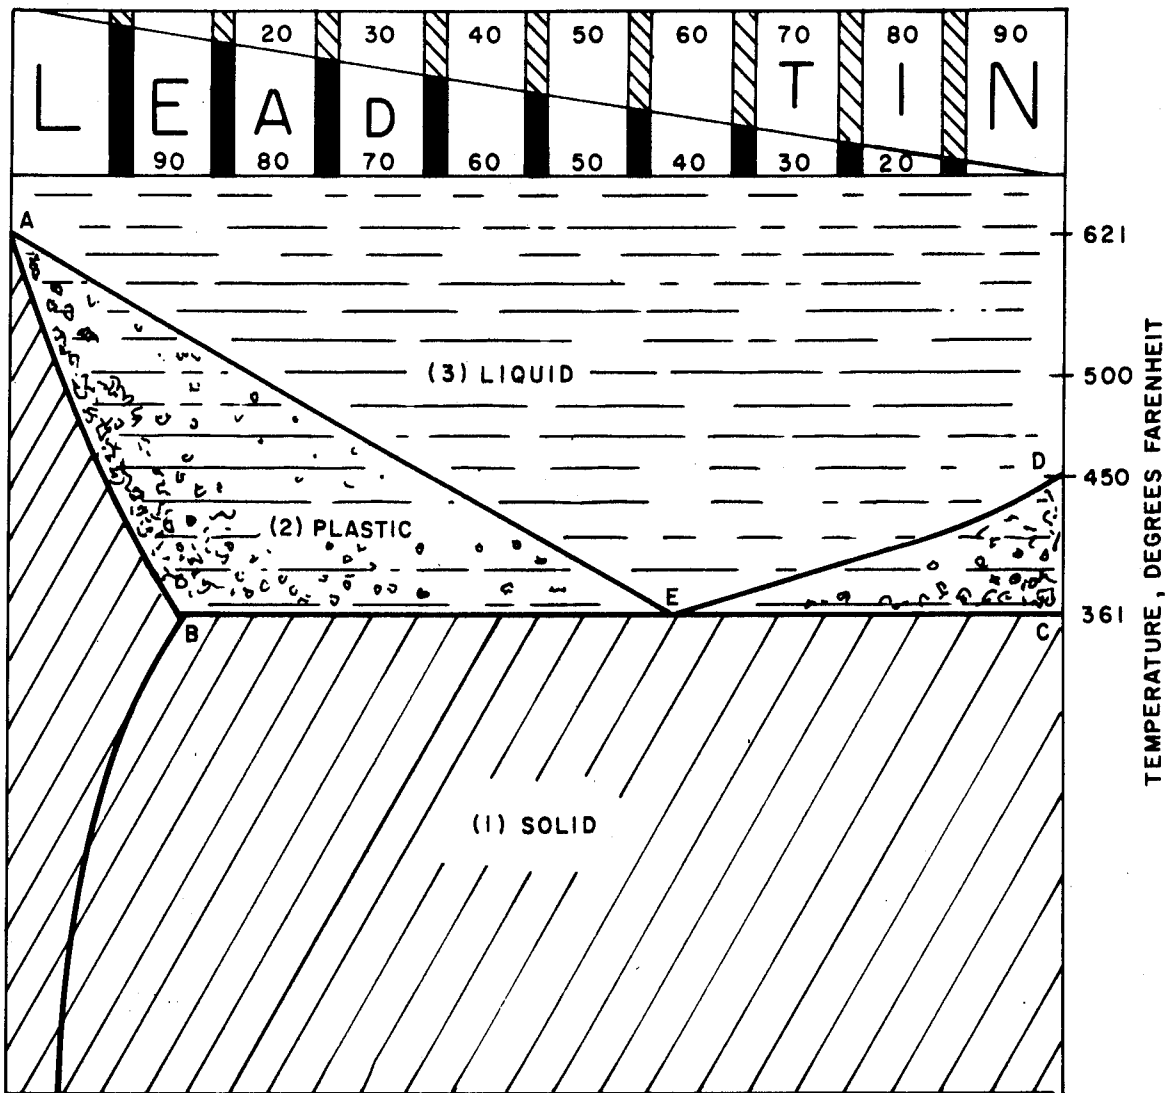
Figure 1. Tin-Lead Phase Diagram

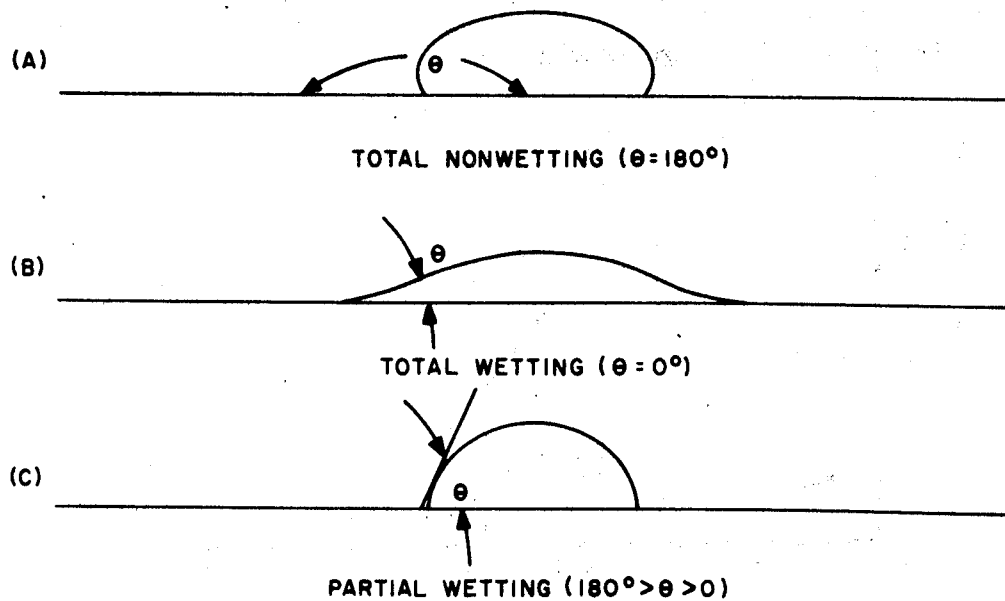
Figure 2. Relation Between Dihedral Angle θ and Degree of Wetting.

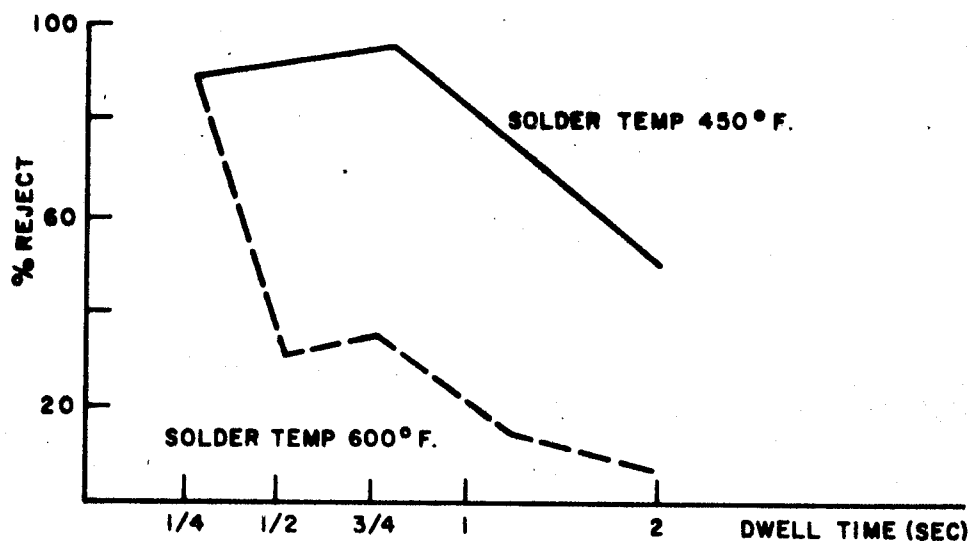
Figure 8. Wire Clean - Board Oxidized

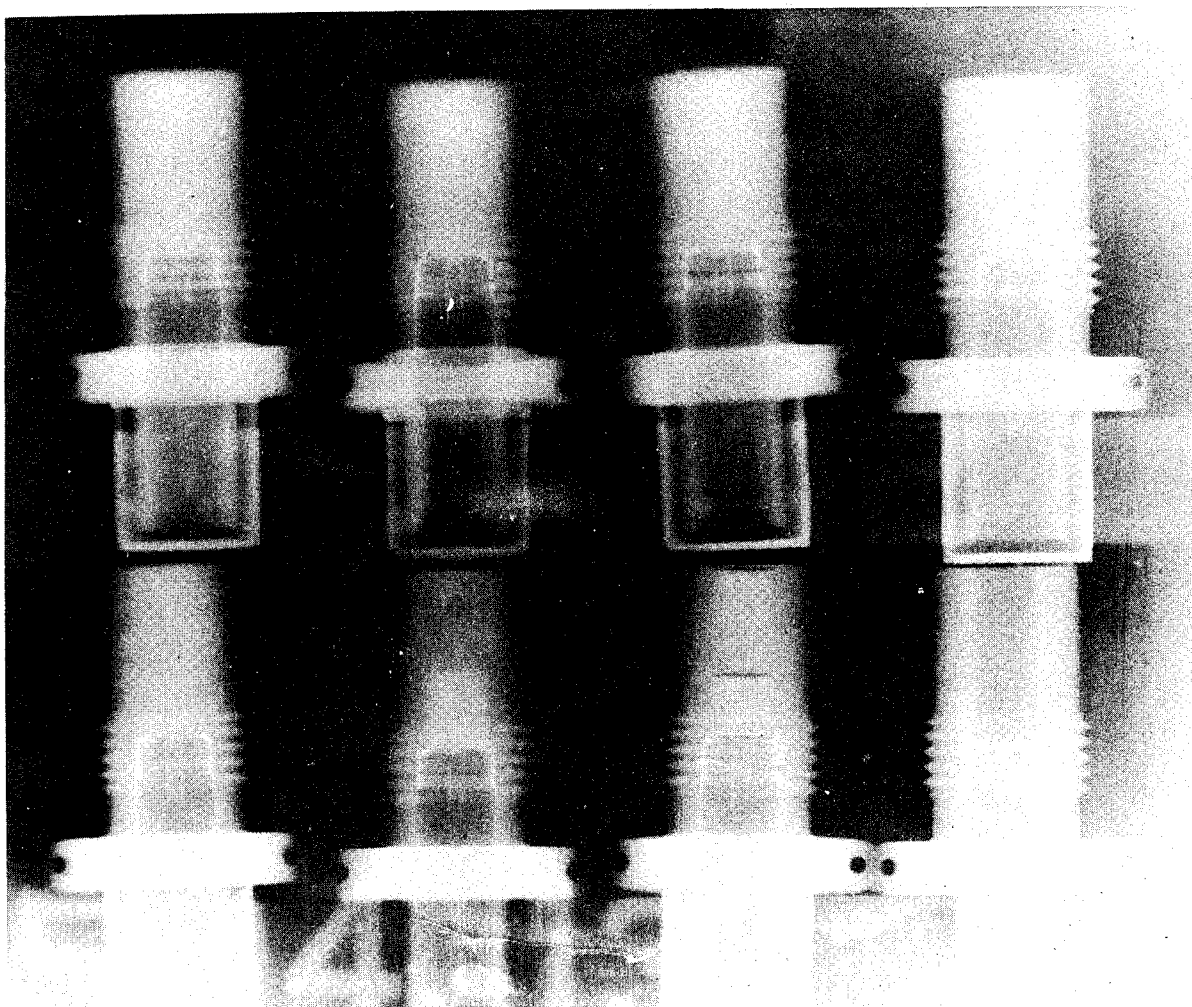
Upper row and lower left detonators show no discontinuities;

14 - bottom row - contains remelted PETN in lower half and low density powder in upper half

lower right - empty

Figure 1. Neutron Radiograph of POLARIS EBW Detonators

Sample	
2	Mid-cavity gap in PETN, and gap between PETN and mica disc.
6	Slight gap between PETN and mica disc; slight radial shrinkage of PETN.
7	Charge completely melted out of cavity with end closure intact.
9	Gaps at mica disc, in center of cavity, and at the bridge-wire; radial shrinkage of PETN.
13	Gaps at mica disc, in center of cavity, and at the bridge-wire; radial shrinkage of PETN.
14	Cast and powdered loads visible, no defects.
16	Charge completely melted out of cavity, lucite insert is visible.
17	Dispersed crystalline PETN visible.
18	Charge completely melted out of cavity.
19	Gaps at mica disc, in center of charge, and at bridgewire; slight radial shrinkage of PETN.
20	Water in PETN visible near top of cavity.

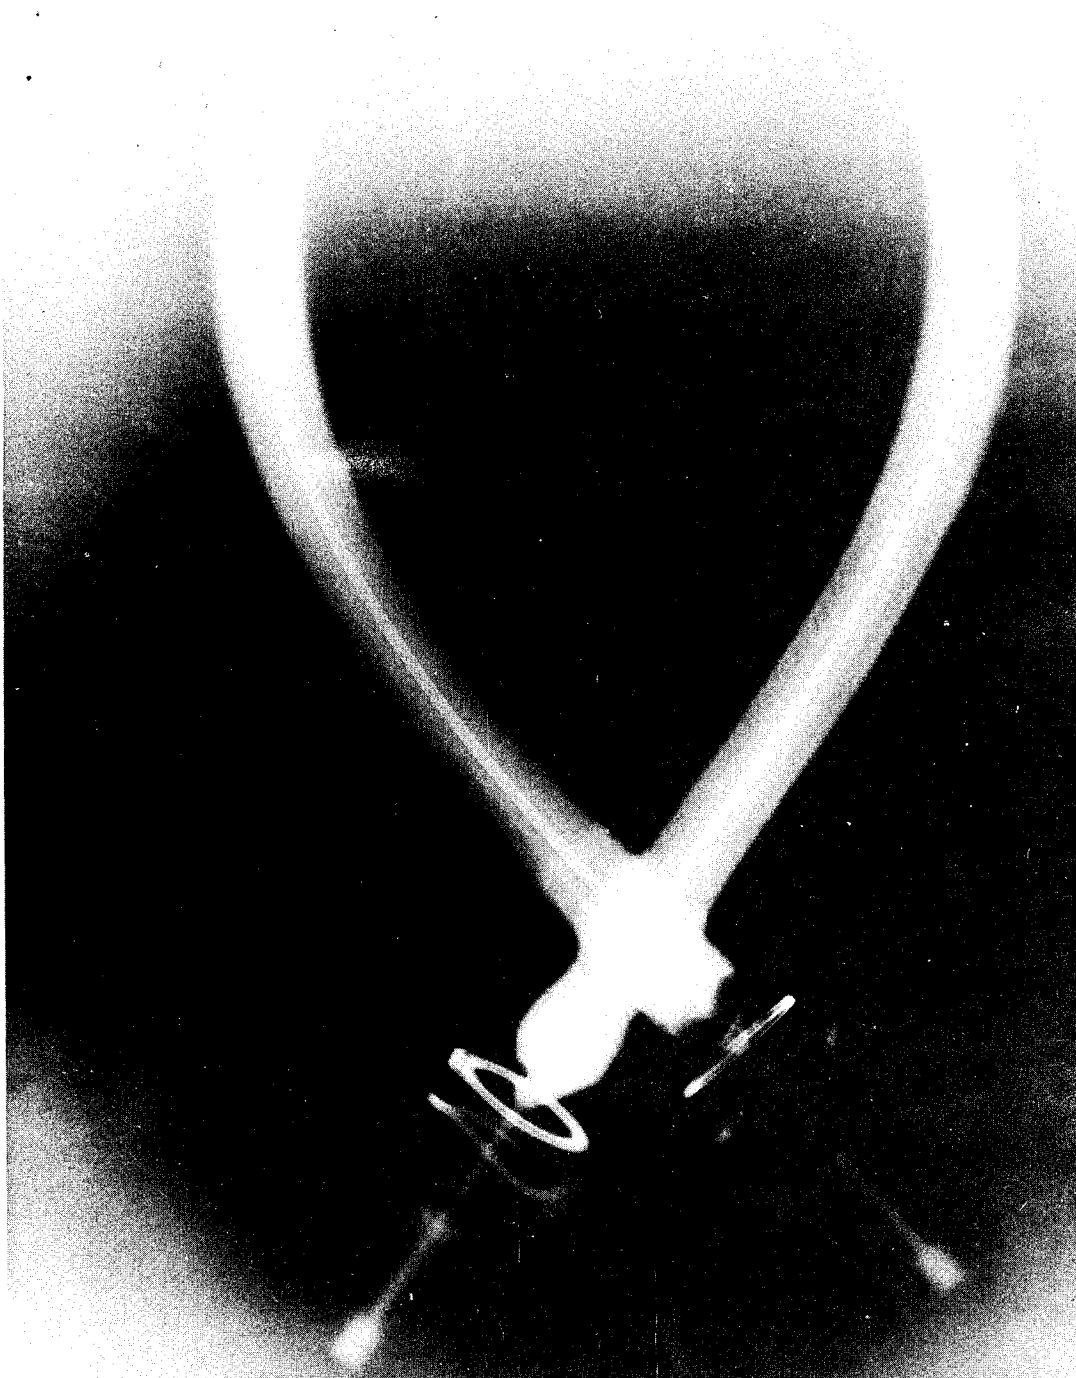
Figure 2. Neutron Radiograph of Explosive Strand Assembled to explosive detonators at the ends

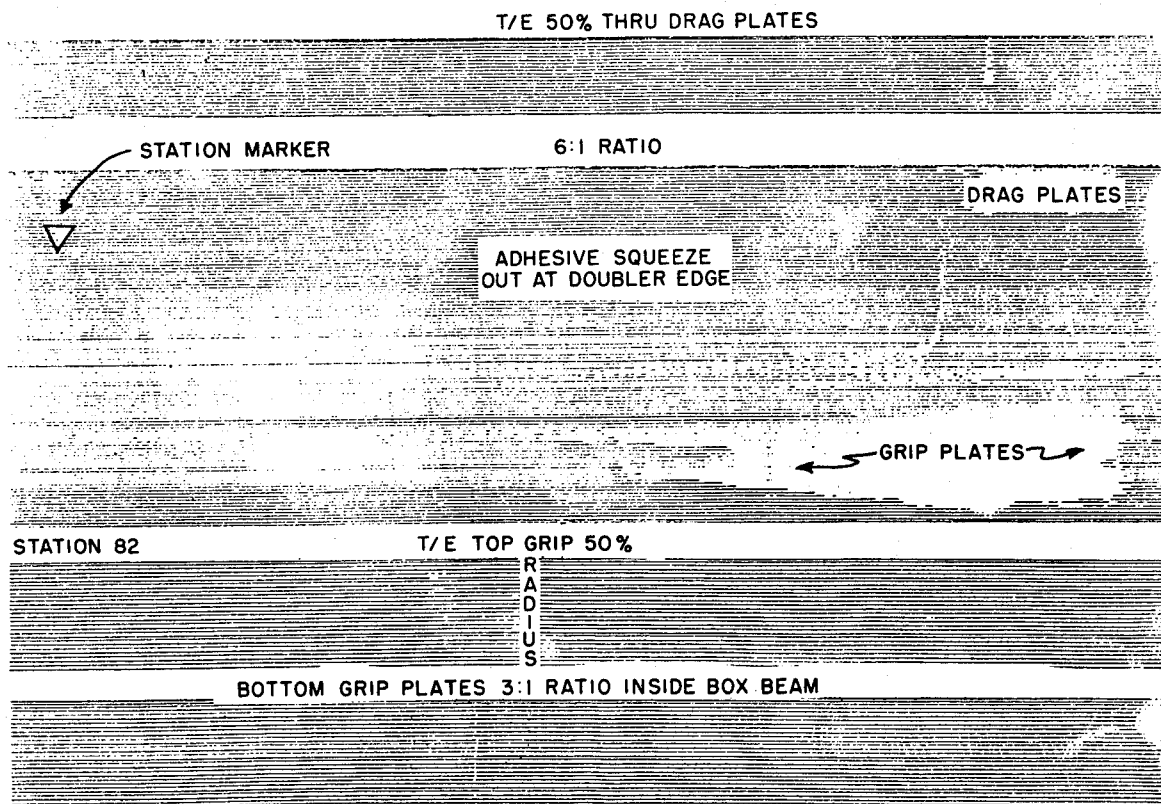
Figure 7. Ultrasonic Record of Blade Inspection

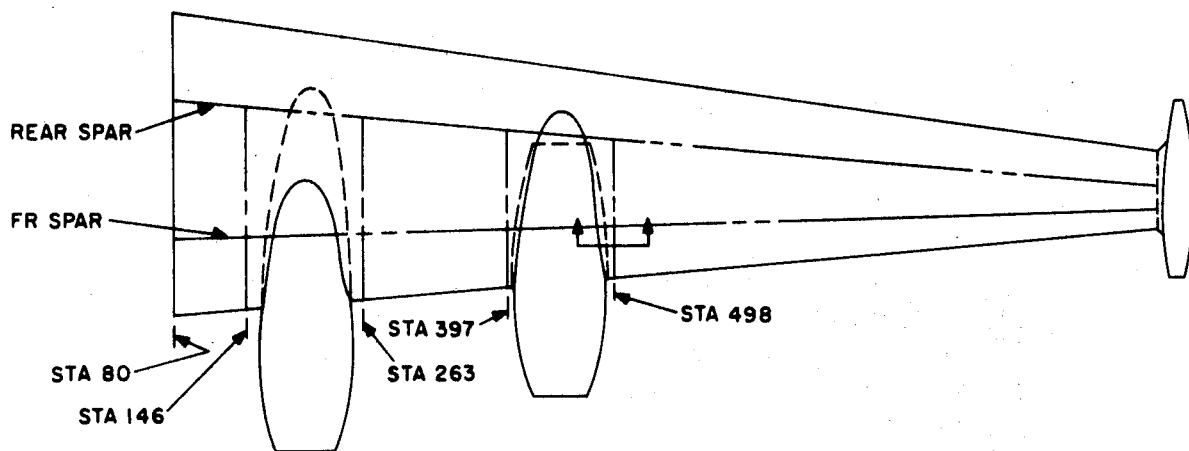
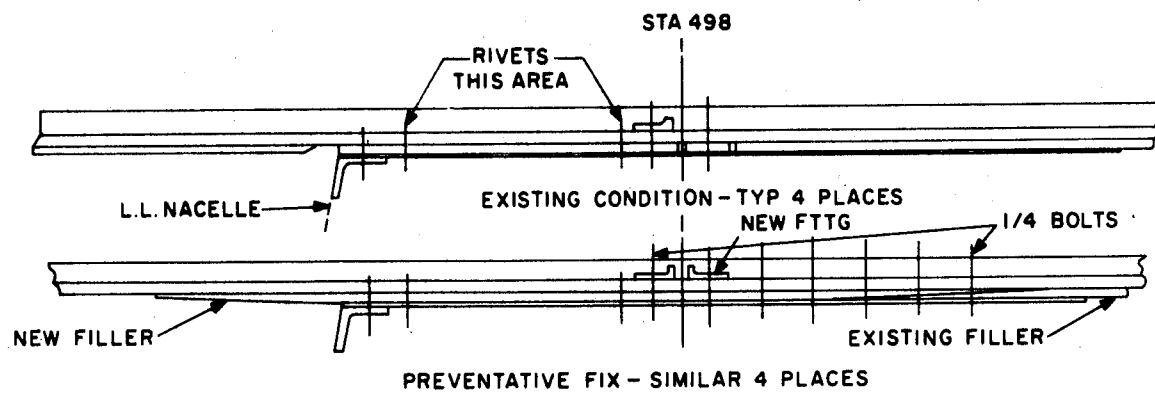
Figure 1.

REPAIR PROCEDURE PER DWG 5458547

1. REMOVE LEADING EDGE
2. REAM 1/4 BOLT HOLES TO .032 OVERSIZE
3. ADD FILLER & TAPER SPLICE TO EXISTING FILLER
4. REPLACE (1) FTTG WITH NEW FTTG TO NEST INSIDE FLANGE
5. REPLACE EXISTING RIVETS WITH 3/16 OVERSIZE SCREWS
